Colton Bryant
Patterson-UTI Drilling Company
307815050/S00706
November 27, 2006

Subject: Fatality Report
Colton Bryant
Patterson - UTI Drilling Company

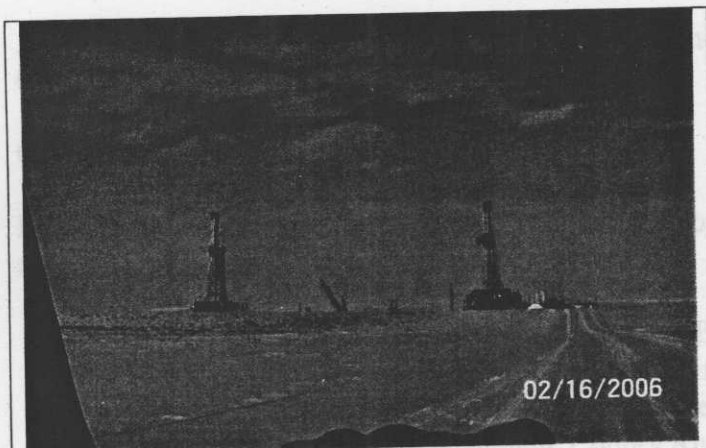
View of rig 455 and 515 from access road.

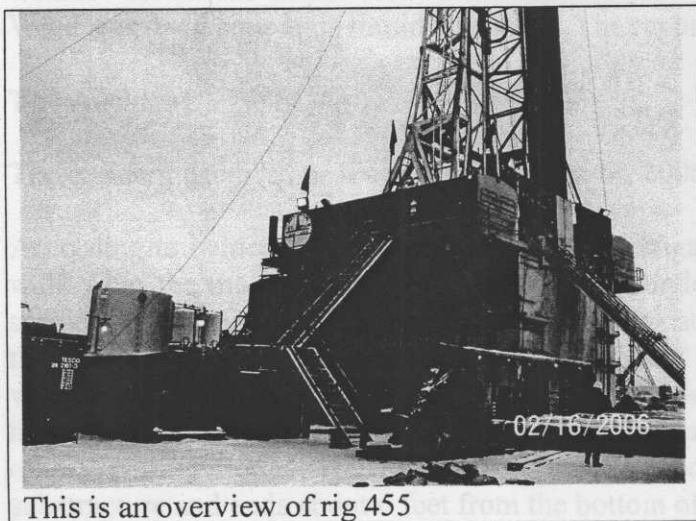
This is an overview of rig 455

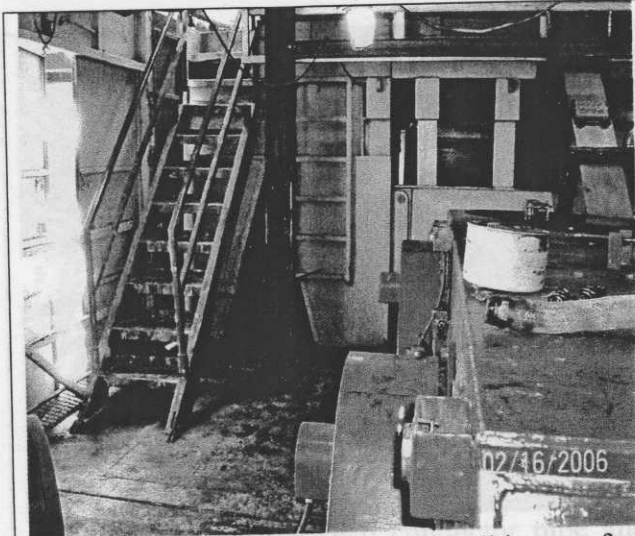
View of entry way to grated walking surface under drill floor of rig 455 while facing south from motor room

- No JSA/Safety meeting records were provided for the day of the accident.
- The safety railing available in the area associated with the grated walking surface/catwalk directly under the drilling floor is not adequate. The grated walking surface leading up to the catwalk has no railing.

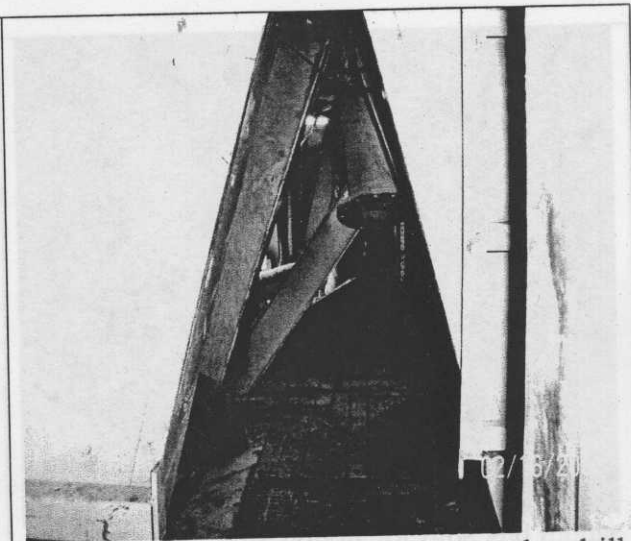
View of grated walking surface under drill floor of rig 455 while facing south from motor room.

Second, the substructure grated walkway/catwalk surfaces located under the drilling floor have inadequate to no safety railing system in some areas. The railing system did not completely enclose the walking surfaces associated with the catwalk constructed around the conductor pipe and mouse hole which creates a fall hazard for anyone not using a tie off method while in the area. There was also no safety railing on the inside of the grated walkway leading to the catwalk.

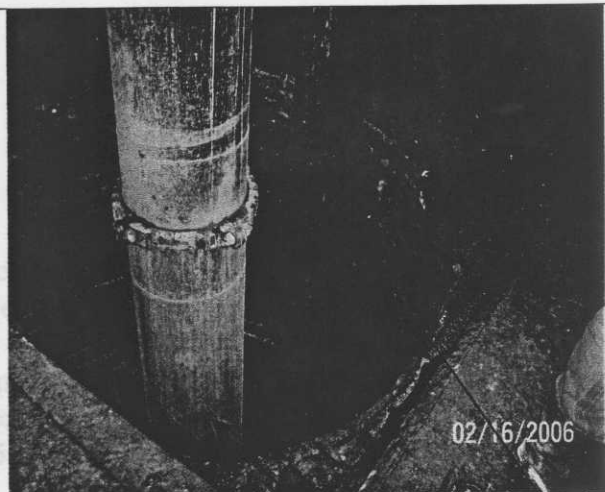
View of cellar with conductor pipe and mouse hole pipe while facing southeast at ground level in the substructure rig 455

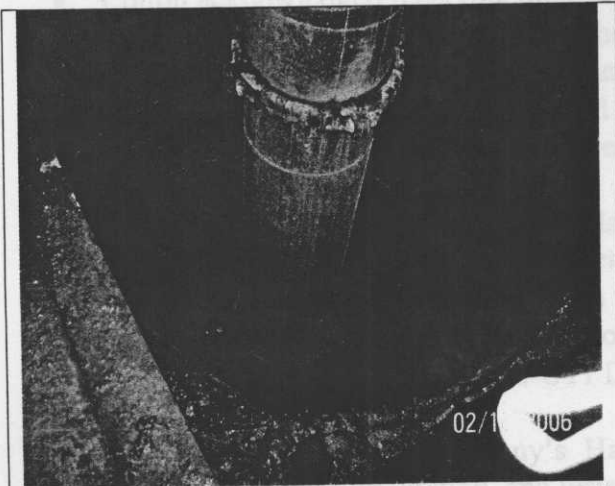
View of cellar as you walk by at ground level in the substructure of rig 455 while facing southeast.
