FATAL NARRATIVE
Joshua Duane Riedel
Nabors Drilling USA LP
307810747

July 23, 2004 at approximately 7:30pm.

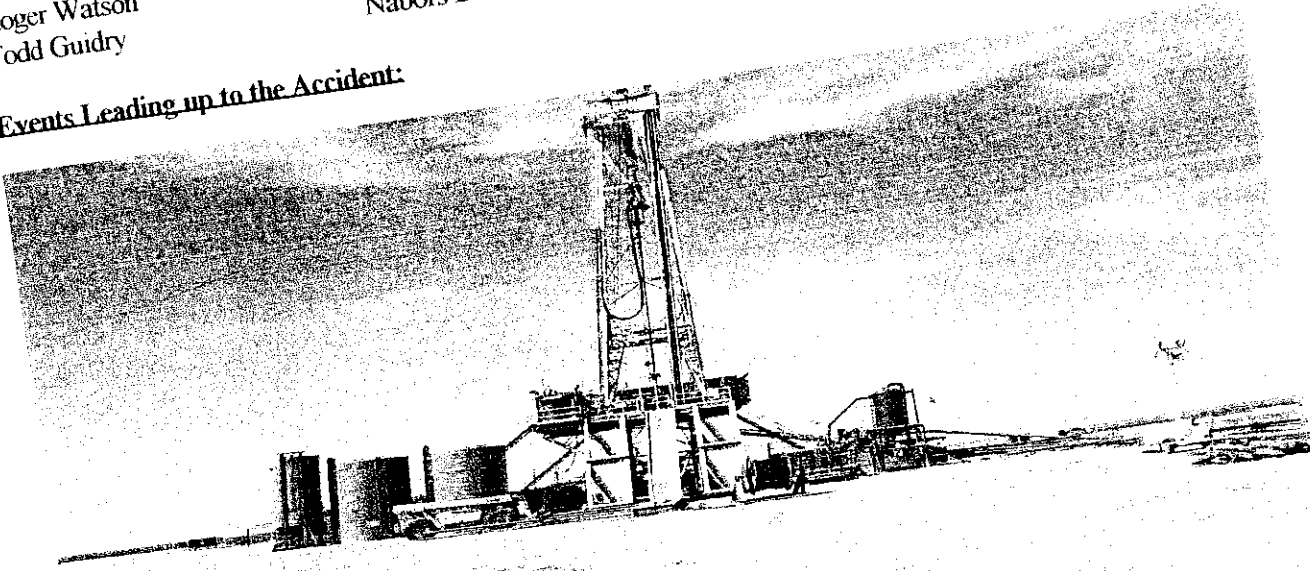
Rig #521 was winterized and a cathode splitter valve was installed on the driller console. The cathode splitter valve was designed by National Drawworks and installed by Tri-Point Energy Services, located in Liberty, Texas. The winterizing process took between 40-50 days to complete. Rig # 521 was transported to Wyoming and was in the process of drilling its first hole when the accident occurred.

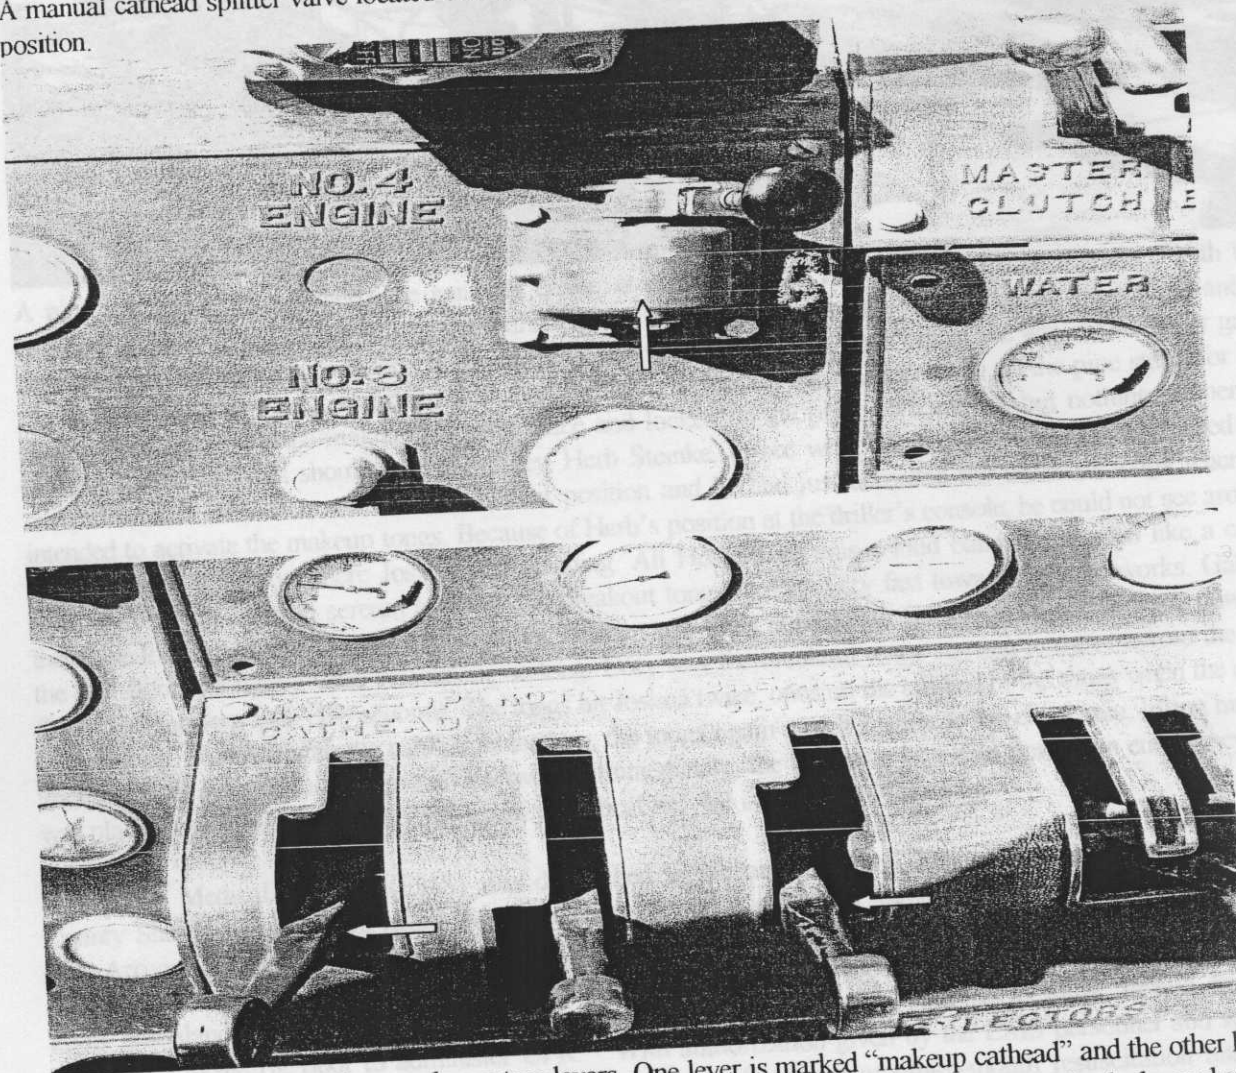
A manual cathead splitter valve located on the driller's console could be placed in either the makeup or breakout position.

Also located on the driller's console are two levers. One lever is marked "makeup cathead" and the other lever is marked "breakout cathead". At the time of the accident, the makeup lever was used for both the makeup and breakout processes. The breakout lever was not operational. The driller would place the cathead splitter valve in the desired position, makeup or breakout, and then use the one lever to complete the process.

- The controls on rig # 521 were altered to eliminate using the breakout lever located on the driller's console.
- The makeup lever on rig # 521 controlled the makeup and breakout operations.

- Install the cathead splitter valve according to manufacturer's installation procedures.
- Routine on-site safety audits/inspections should be performed.
- Ensure all control levers are functioning as per the rig manufacturer's criteria.
- Before any rig modification(s) take place, all the potential consequences should be discussed not only with the supervisor but with all the affected employees as well.
- All employees should constantly assess the operation for safety hazards. If an employee(s) is positioned in a hazardous location, stop the operation and correct the hazard or the potential hazard immediately.
- Ensure new drillers are adequately supervised, especially when they are operating equipment they are unfamiliar with.
- All company employees should be briefed on the events of this accident.

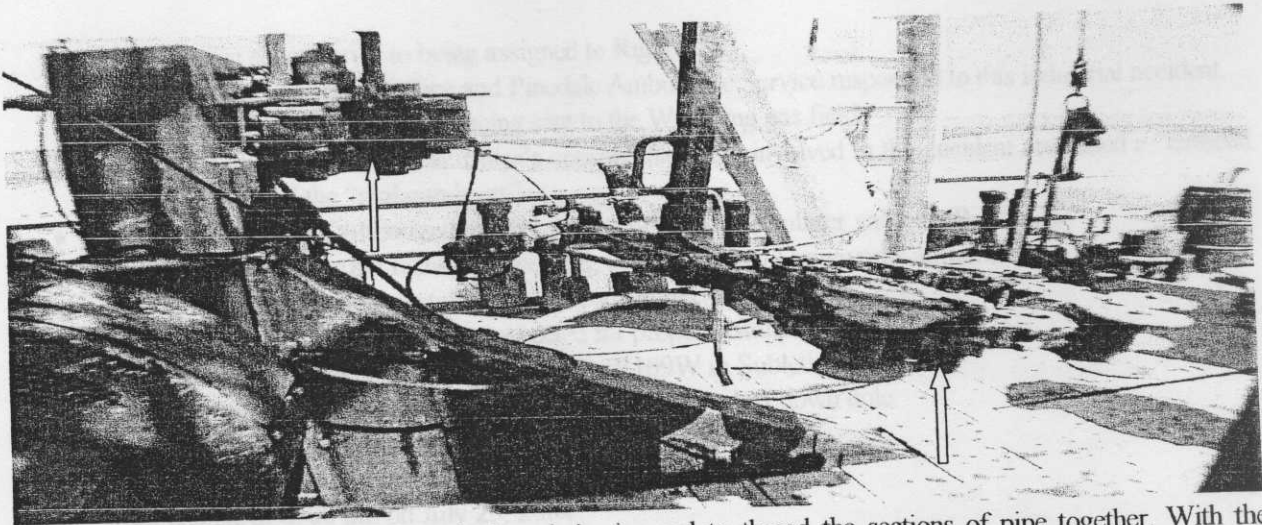
A pipe spinner, which replaced the spinning chain, is used to thread the sections of pipe together. With the breakout tongs secured to the A leg, floorhand Joshua Riedel placed the pipe spinner on the pipe stand and it threaded together correctly. He then removed the pipe spinner and held it back out of the way. The driller gave the okay for Gabriel Flagg, with help from Guy Cabral, to position the makeup tongs on the pipe stand for the torque to be set. With the makeup tongs in place and locked on the pipe, both waited, but nothing happened. Gabriel looked over his shoulder at the driller, Herb Steinke, to see what the problem was. Herb realized the cathhead splitter valve was still in the breakout position and he had just activated the breakout tongs when he intended to activate the makeup tongs. Because of Herb's position at the driller's console, he could not see around the console to the floor where Joshua was standing. All Herb heard was a loud bang. It sounded like a cable breaking. Gabriel heard a scream and saw the breakout tongs moving very fast toward the drawworks. Gabriel then saw Joshua positioned on the drawworks. At the same time, derrickman Cory Fowler was looking down to the drill floor wondering what was taking so long. Cory saw the breakout tongs starting to move across the drill floor. This incident took only seconds. The tongs hit Joshua twice, once on the tail end of the tongs when the cable tightened up, and then with the cable tightened up, the tongs again struck Joshua in the chest area, lifting him up about six feet in the air and onto the drawworks. Immediately, the operation was shut down. An emergency call was placed to the Sublette County Emergency Medical Service in Pinedale, Wyoming.
