Fatality Narrative

Debra Lee Zeleny
Merit Energy Company
305653305/P1128

OSHA Photo Evidence

Casefile No.: 305653305
Date of Mishap: 04/06/03

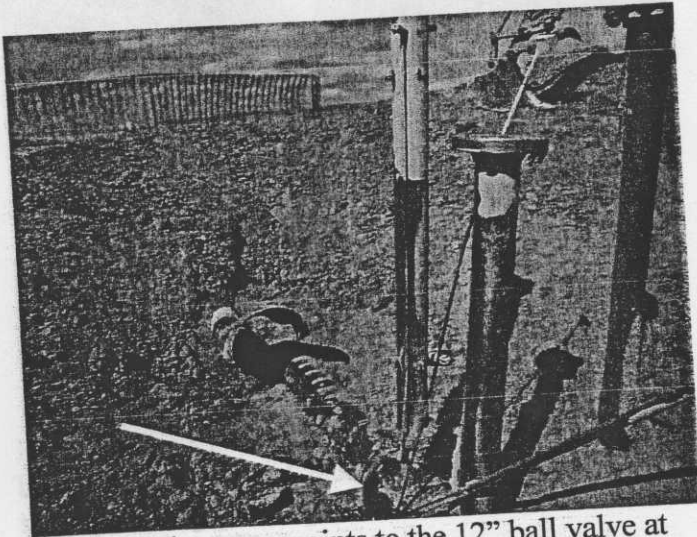
Photo #1 The arrow points to the 12" ball valve at the Powell site. It was beneath about 7' of soil prior to the mishap. The valve stem extended to the surface where a wheel was located to operate the valve. The capped off line to the front of the photo was the smaller connecting line from the Powell unit.

Approximately 12 miles south of the North Buck compressor plant is an intersection in the pipeline where gas from the Powell Pressure Maintenance Unit [Powell] compressor plant can be added. At this intersection, a ball valve was located in the main 12" line as well as a valve for the smaller pipeline entering from the Powell unit. The 12" ball valve was located approximately seven feet underground and was in line with the pipeline. A hand wheel above the surface of the ground on the valve stem pedestal operated the valve. (See **Photos #1 thru #3.**)

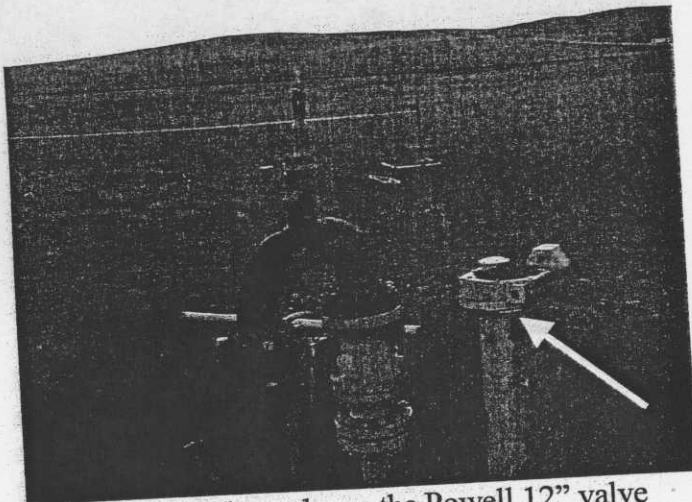
Photo #3 This photo shows the Powell 12" valve pedestal (arrow) with the wheel broken off. The intersecting Powell unit feeder gas pipeline and valve are located to the left of the pedestal.

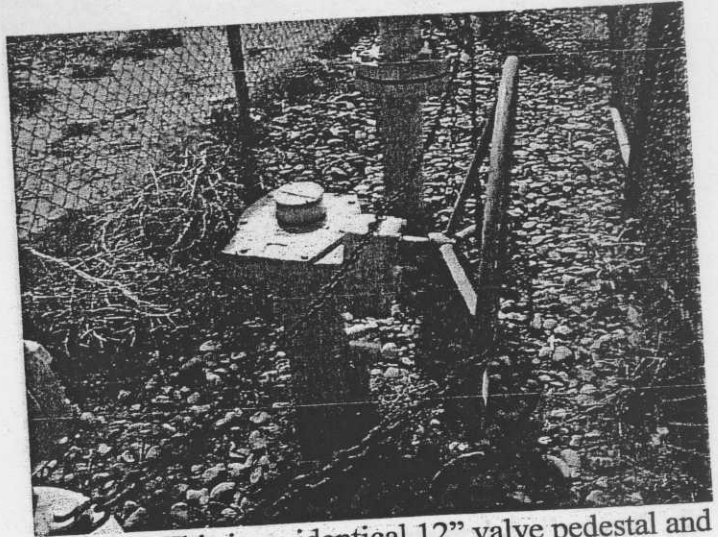
Photo #2 This is an identical 12" valve pedestal and wheel at the Spearhead Ranch location along the Sage Creek pipeline.

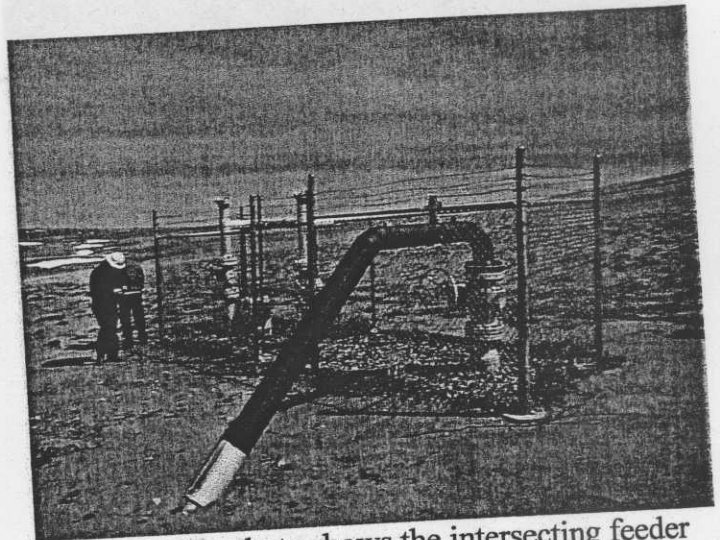
Photo #4 This photo shows the intersecting feeder gas pipeline at the Spearhead Ranch location. The chain link fence surrounding the valves is very similar to what had been in place at the Powell valve location.

Approximately 12 miles further down the line from Powell is a valve named Spearhead Ranch. At this location, an identical ball valve is located underground in the 12" gas pipeline. A smaller feeder gas line also intersects the 12" line at this location to add more gas to the pipeline. This site is surrounded by a chain link fence; much like what had been located at the Powell valve site. (See **Photo #4.**)

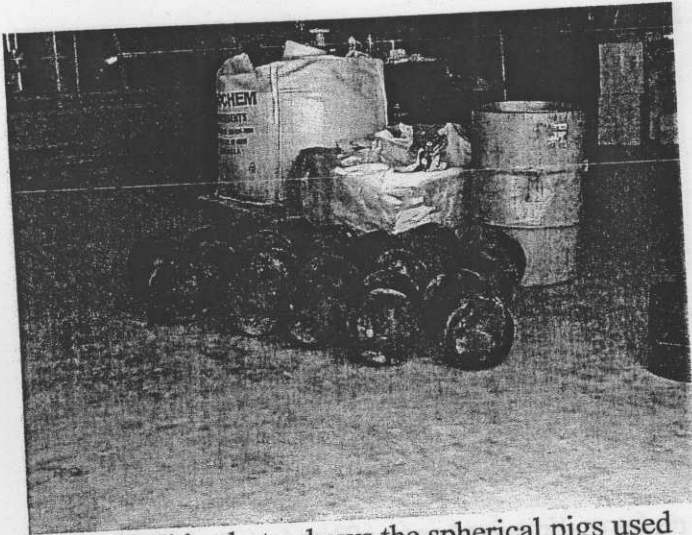
Photo #5 This photo shows the spherical pigs used by Merit in the Sage Creek pipeline. The pigs clean the pipeline by pushing condensates down the line as the pig travels with the gas.

The Sage Creek operator sets the interval at which spherical devices called pigs are automatically released from the North Buck plant into the Sage Creek pipeline (see **Photo #5**). The release interval is seasonally adjusted (more frequent releases in cold months) and is based on volume of gas flowing in the pipeline. The pigs travel through the pipeline pushing condensates down the line to Sage Creek. The pigs are hollow and made of a dense rubber like material. They are filled with a glycol solution. In the cold weather months, the pigs are released automatically into the system approximately every six hours. At any given time, a number of pigs will be present at intervals within the 37 mile long pipeline.

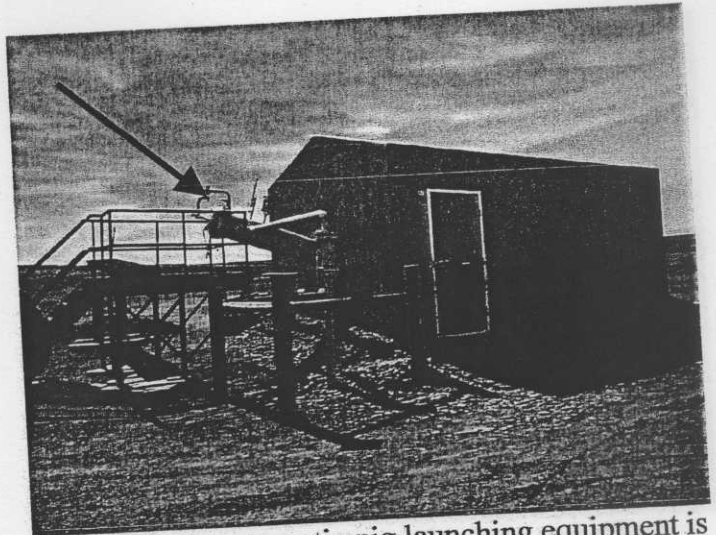
Photo #6 The automatic pig launching equipment is housed in this outlying building at the North Buck Draw plant. The magazine (arrow) is manually loaded with enough pigs for several day's worth of releases.

The launching equipment at the North Buck plant is self-contained and only requires reloading of the pig magazine every two or three days – see **Photo #6**. The pigs are then automatically released into the 12" Sage Creek pipeline based on the preset gas flow rate. When the pigs arrive at the end of the pipeline, automatic receiver equipment at Sage Creek captures the pig – see **Photo #7**. The receiver is then manually emptied and the pigs are cleaned and made ready for transport back to the magazine at the North Buck plant where they are again introduced into the pipeline.

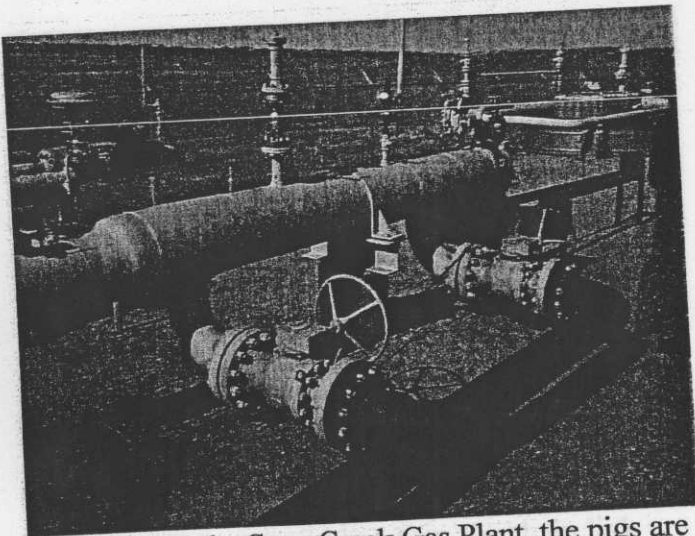
Photos #7 At the Sage Creek Gas Plant, the pigs are automatically routed to this receiver. From here they are manually removed, cleaned, and made ready for transport back to North Buck Draw and reuse.

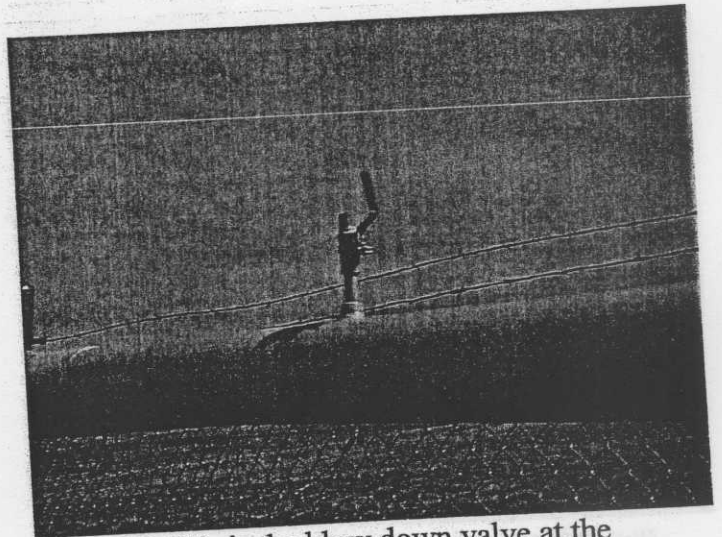
Photo #8 This is the blow down valve at the Spearhead Ranch valve site. This valve was used to bleed the pressure to zero in the Sage Creek 12" pipeline between the Powell valve and the Spearhead Ranch valve.

Mr. Zimbelman asked Ms. Zeleny and Ms. Iriberry to remain at the Powell 12" valve site while he drove to the Spearhead Ranch valve site. This location is approximately 12 miles further downstream along the Sage Creek pipeline. When Mr. Zimbelman arrived at the Spearhead Ranch valve site, he shut the 12" ball valve and began to blow down the upstream line pressure. When this was done, the pipeline between the closed Powell valve and the closed Spearhead Ranch valve was at zero pressure. The blow down port (see **Photo #8**) was left open.

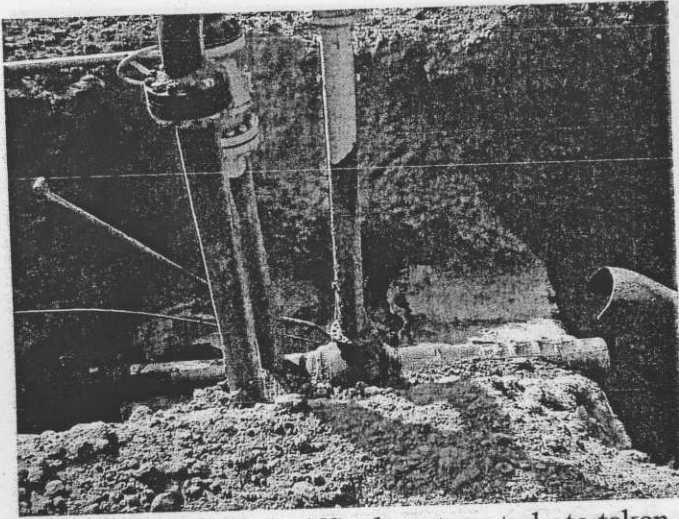
Photo #9 This is a sheriff's department photo taken within three hours of the mishap. The 12" pipeline is ruptured at the right of the photo. The 12" ball valve is in the center of the photo. Escaping gas from the ruptured pipeline formed the crater.

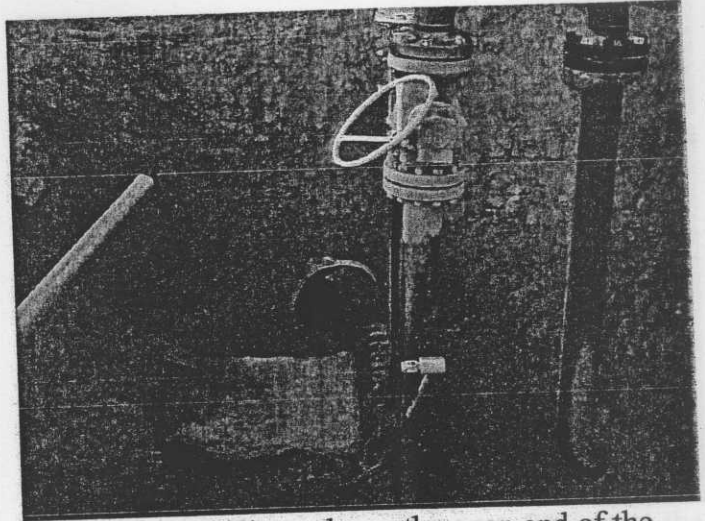
As the gas was escaping from the ruptured pipeline, the open end of the pipe was somewhat like a jet nozzle. The kinetic energy directed through this nozzle caused the crater to extend to the south as soil was pushed out and blown southward. For several hundred feet south of the crater, the prairie grass was bent and full of drifted soil.

Photo #10 This photo shows the open end of the ruptured pipeline. The shiny pipe at the left of the photo is a post from the chain link fence that had surrounded the valve site. The rapidly escaping gas from the open pipe formed the crater.

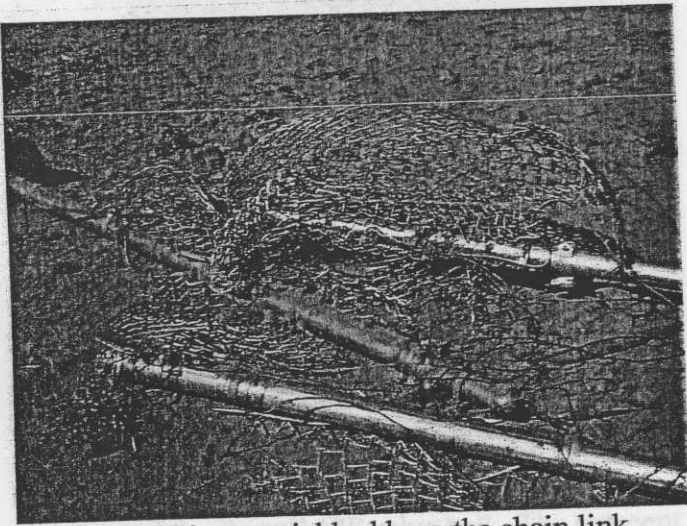
The stored energy of a 12-mile long 12" diameter pipeline full of compressed gas was suddenly released as the pipeline ruptured. The kinetic energy of this escaping gas almost instantaneously hurled the two employees away from the valve pedestal as the ground rose beneath their feet. The gate for the chain link fence was broken loose and came to rest about 57' feet from the valve and in the same general westward direction as the two employees. The valve wheel that the employees were turning was broken from the pedestal and came to rest about 46' westward of the valve. The chain link enclosure fencing had steel posts set in concrete. The fence was some six feet tall. The fence material and posts were rolled, wadded and came to rest about 47' south of the valve pedestal (downwind in the blast of escaping gas) – see **Photo #11**.

Photo #11 This material had been the chain link fence enclosure around the valve site. It was rolled and wadded and came to rest about 47' from the valve pedestal. *the ball appears to be from an impact.*

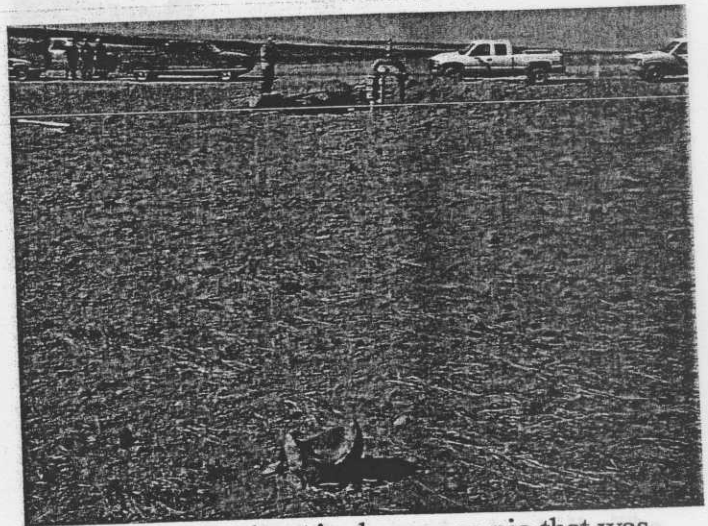
There were three pigs located in the vicinity of the mishap. One was found about 60' from the ruptured pipeline, the second about 552' from the rupture, and the third about 735' from the rupture. All were somewhat south of the scene, in the direction of the escaping gas. (See **Photos #12, #13, & #14**.)

Three pigs were located in the pasture near the mishap scene. These pigs were expelled from the 12" pipeline following the rupture. The pig nearest the scene was significantly damaged. It was likely the first one expelled from the line. It may have impacted the ball of the 12" valve before being expelled in the conflagration as the line ruptured. The second and third pigs were a considerable distance from the scene and likely were not expelled from the open pipeline until sufficient gas had escaped to elongate the crater to the south. The escaping gas impinging on the soil created somewhat of a ramp at the south end of the crater.

Photo #12 This photo shows one pig that was expelled from the pipeline following the rupture. This pig was significantly damaged. This pig was located SSE of the ruptured pipeline.

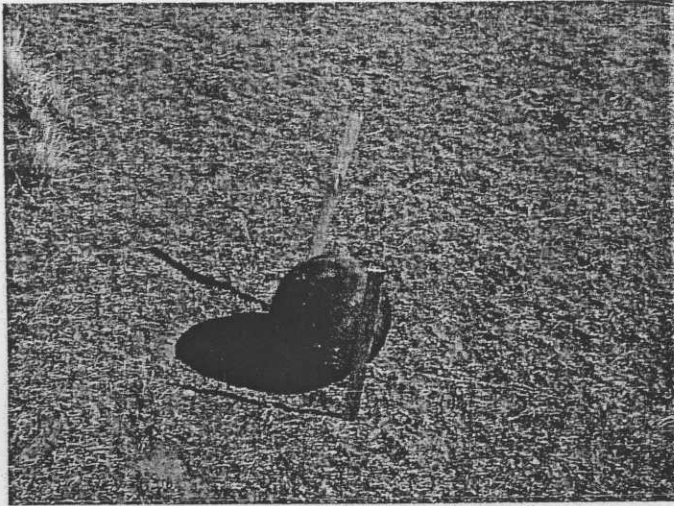
Photo #13 This pig was located some 552' from the ruptured pipeline in a southerly direction.

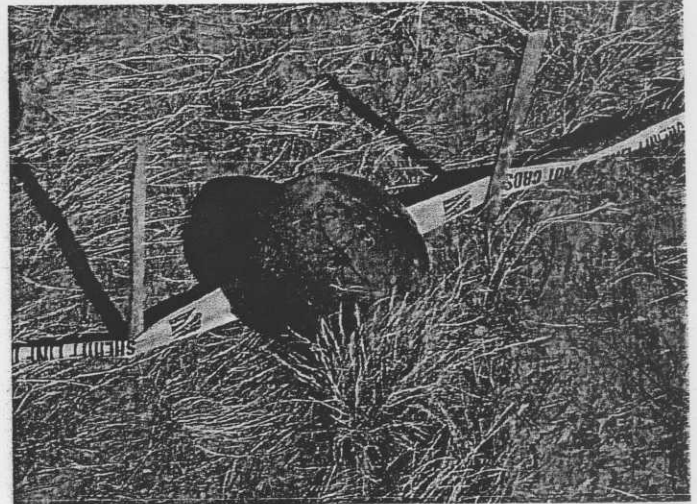
Photo #14 This pig was located some 735' from the ruptured pipeline. The glycol fill port was damaged on this pig. It was somewhat east and a bit further south of the pig in Photo #13.

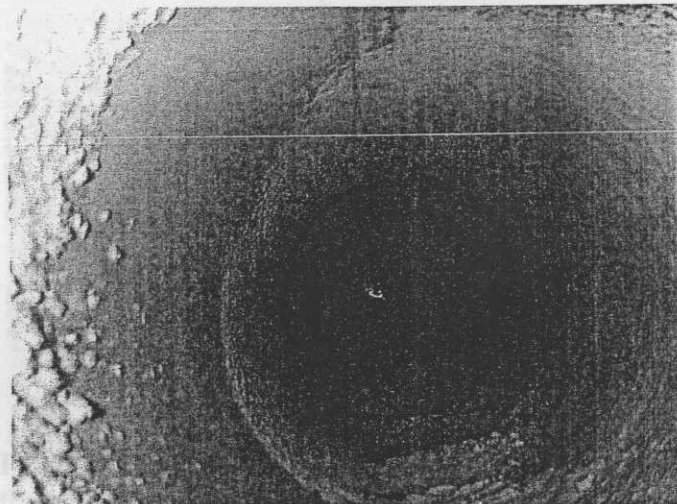
The 12" ball valve at the Powell location was only slightly cracked open when the pipeline ruptured as seen in **Photos #15 & #16**. The valve ball has a mark that appeared to have been made by an object impacting the ball.

Exactly what occurred at the instant they opened the valve is not known. However, it appears that the stuck pig began moving down the pipeline and impacted the ball of the 12" valve these two employees were attempting to open. Simultaneously, the pipeline ruptured beneath the ground about 74" upstream of the valve. The sudden release of compressed gas led to the conflagration at the site. With a section of 12" pipeline some 12 miles long at approximately 700 p.s.i., the kinetic energy of the gas escaping from the ruptured pipeline was phenomenal.

Photo #15 This photo is looking down the stub of pipe toward the Powell 12" valve ball. The crescent at the left of the ball is the slight opening as the ball had just begun to rotate to the open position. The shiny mark on the ball appears to be from an impact.

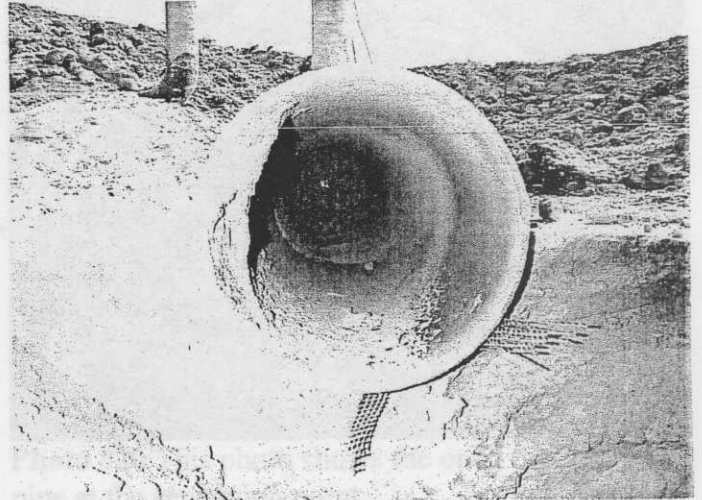
Photo #16 This photo shows the open end of the pipe stub and the slightly opened valve ball. The shiny impact mark is also visible.

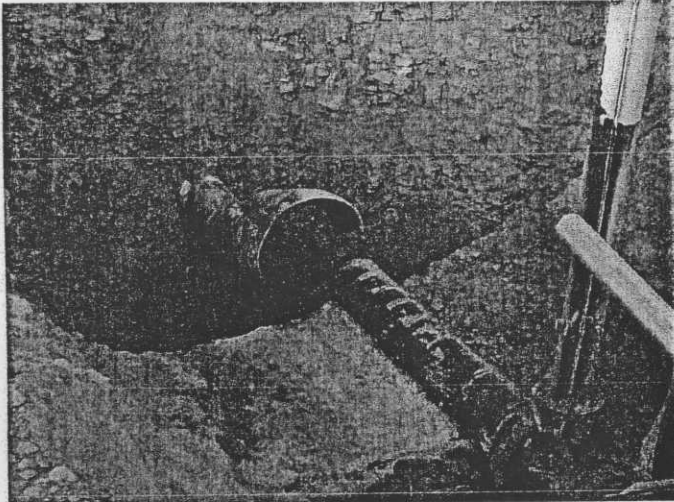
The pipeline rupture occurred about 74" upstream of the center of the 12" ball valve (see Photo #17). Additional views of the ruptured section of pipe can be seen in Photos #18 thru #22.

- When the Powell valve was only slightly opened, the Sage Creek Pipeline ruptured adjacent to the valve.
- The pipeline separated approximately 74" upstream from the center of the 12" valve ball. There was about 7' of soil above the pipeline and valve at this location.

Photo #17 The pipeline rupture occurred about 74" upstream of the center of the ball valve.

- All company employees should review the findings of this investigation.
- Conduct “smart pigging” or other testing and evaluation of the pipeline in the vicinity of the rupture to check the integrity of the pipeline and associated welded joints.

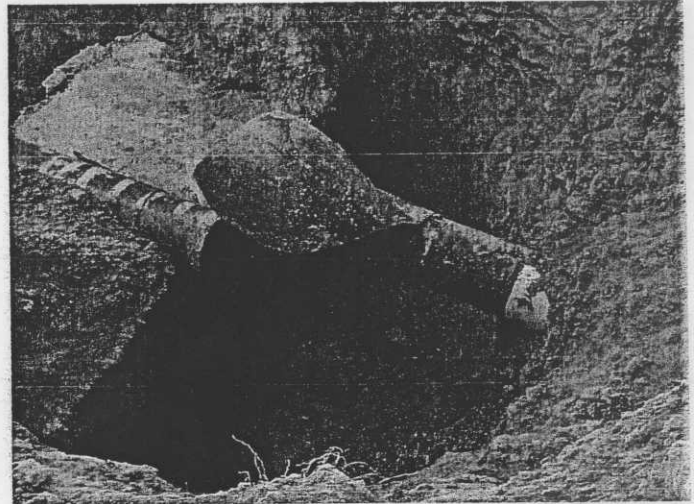
Photo #18 This photo shows the ruptured section of the pipeline from a secondary angle.

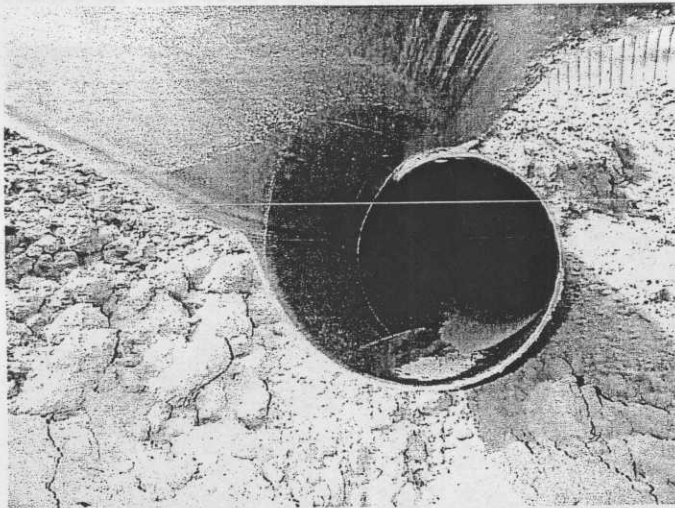
Photo #19 This photo is a close up of the interior of the open end of the ruptured pipeline.

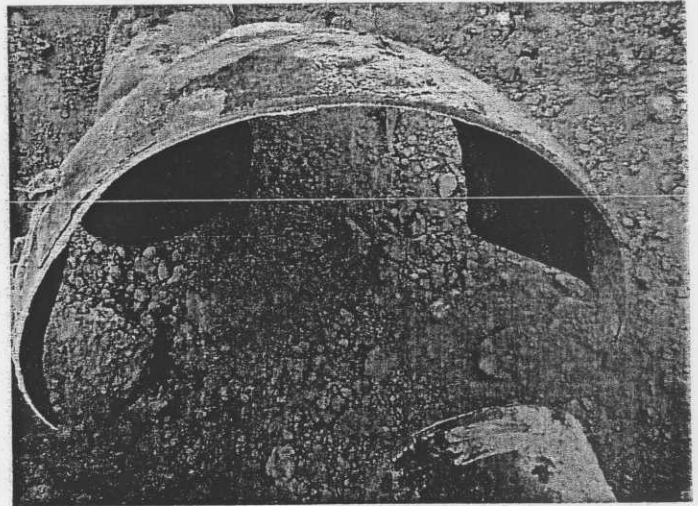
Photo #20 This photo shows the open portion of pipe at the separation point.

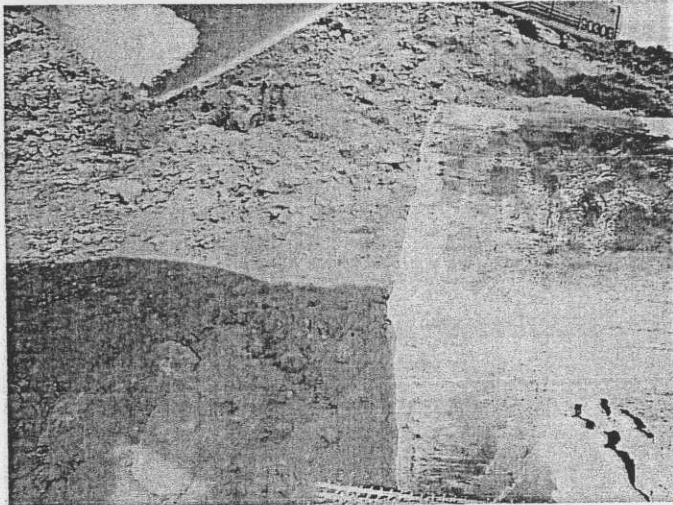
- 3) The pipeline and/or the weld at the rupture point were already weakened from manufacturing or installation flaws. The added shock loading from the pig impacting the valve was sufficient to cause a rupture at the flaw.

Photo #21 This photo shows the end of the stub of pipe attached to the ball valve. The weld bead is visible on this section of pipe.

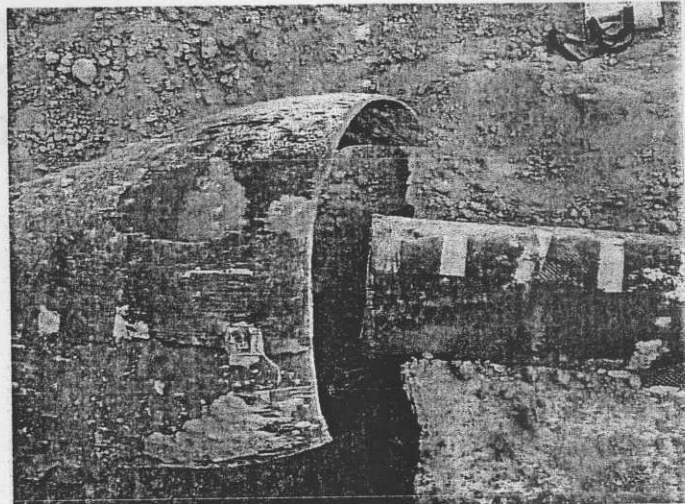
Photo #22 This photo shows the two sections of pipe at the rupture.

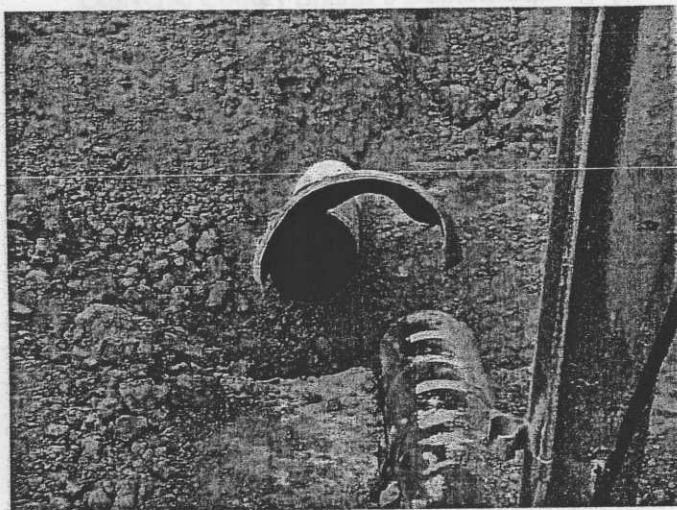
- The ball of the 12" valve had a mark indicating an object impacted it.
- The sections of the pipeline at the rupture are laterally offset by more than one pipe diameter as seen in **Photo #23**.

- 4) The pipeline and/or weld were weak and the sudden rise in pressure as the pig passed by was sufficient to initiate the failure sequence.
- 5) The pipeline was misaligned laterally at the point of rupture, which had induced stress related weakening in the weld or pipe material over the time since installation.

Photo #23 This photo shows the lateral misalignment of the ruptured pipe following the mishap. The sections of the 12" pipeline are offset by more than one pipe diameter.
